Manhole Inspection Summary

Manhole # S23EE1009MH

Insp Date: **7/2/07 2:21 PM**

Location Address: **1503 COX ST**

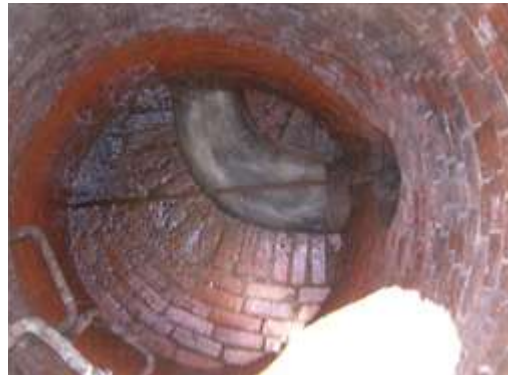
Top View

Steps Count: **4** Missing: **0** ☒ **Corroded**

Corroded steps.

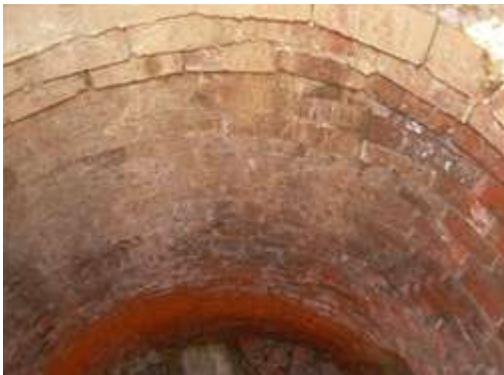
Defect

Infiltration: ☐ None ☒ **Joint** ☐ Cracks ☐ Mortar ☐ Roots ☒ **Wall**

Adjustment infiltration.

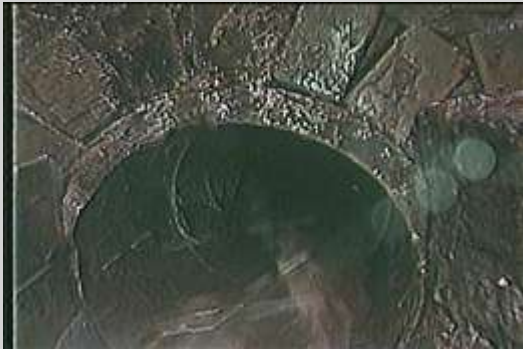
12 in. Circular Gravity Sewer Pipe Out @ 12 O'Clock

Infiltration: **None** Pipe Seal Cond: **Cracked**

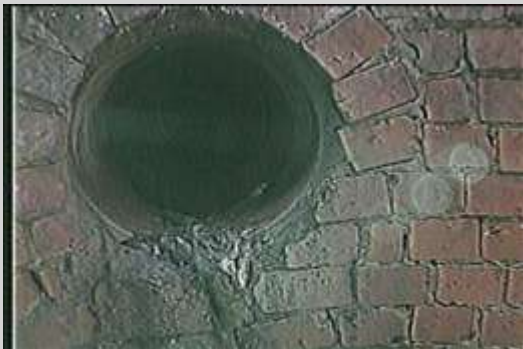
12 in. Circular Gravity Sewer Pipe In @ 3 O'Clock

Condition: ☐ Sound ☐ Cracked ☐ Root Intrusion ☐ Loose Brick ☒ **Deteriorated**

Infiltration: ☐ None ☐ Joint ☐ Cracks ☒ **Mortar** ☐ Roots ☐ Wall

Barrel deterioration and infiltration.

Infiltration: **Evidence** Pipe Seal Cond: **Cracked**
